APS31 / 41

Gearbox Breakdown

Part #5005/216

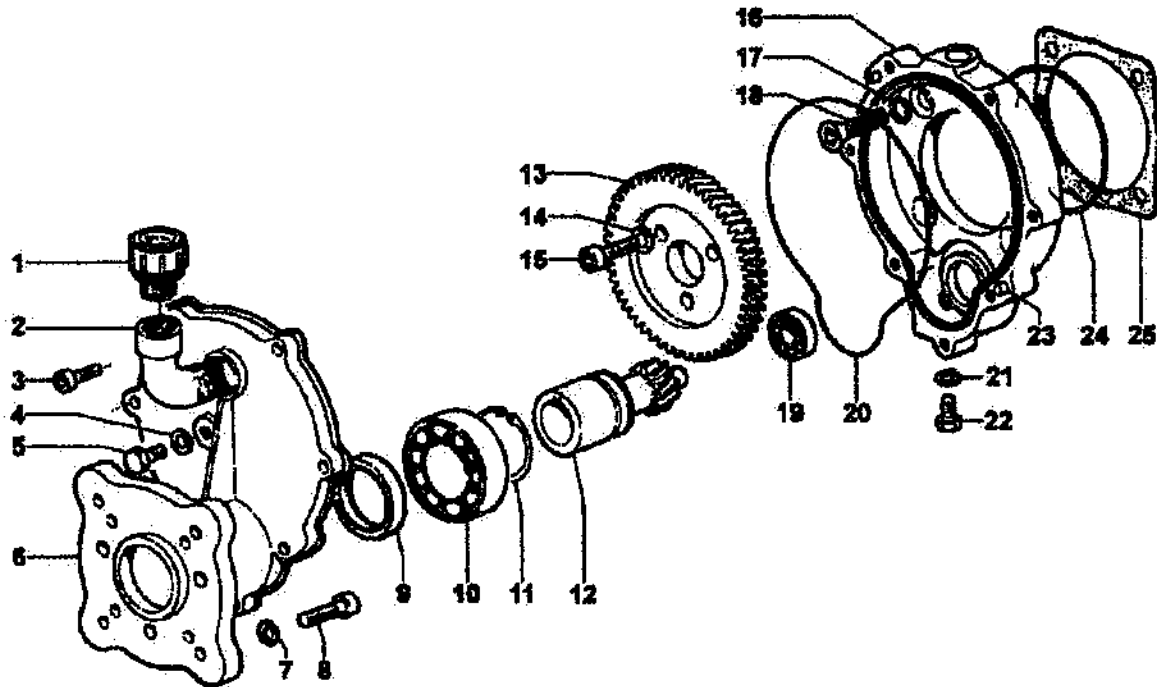
Reference	Part Number	Description	Quantity
1	3200/82	oil vent cap	1
2	1211/23	elbow	1
3	3609/41	screw	7
4	2811/51	washer	1
5	3607/214	level indicator plug	1
6	3002/559	body	1
7	2811/4	washer	4
8	3607/119	screw	4
9	19/109	oil seal	1
10	438/68	bearing	1
11	3019/4	retaining clip	1
12	2402/152	shaft	1
13	409/14	gear	1
14	2811/98	washer	3
15	3609/22	screw	3
16	3001/151	body	1
17	1210/93	o-ring	4
18	3621/6	screw	4
19	438/54	bearing	1
20	1210/89	o-ring	1
21	2811/51	washer	1
22	3607/214	oil plug	1
23	2818/5	stabilizing pin	2
24	1210/50	o-ring	1
25	1201/21	gasket	1
